Incidental Change in Photopeak During A Dynamic Renal Scan

Case Report

Iran J Nucl Med 2009;17(2):55-57

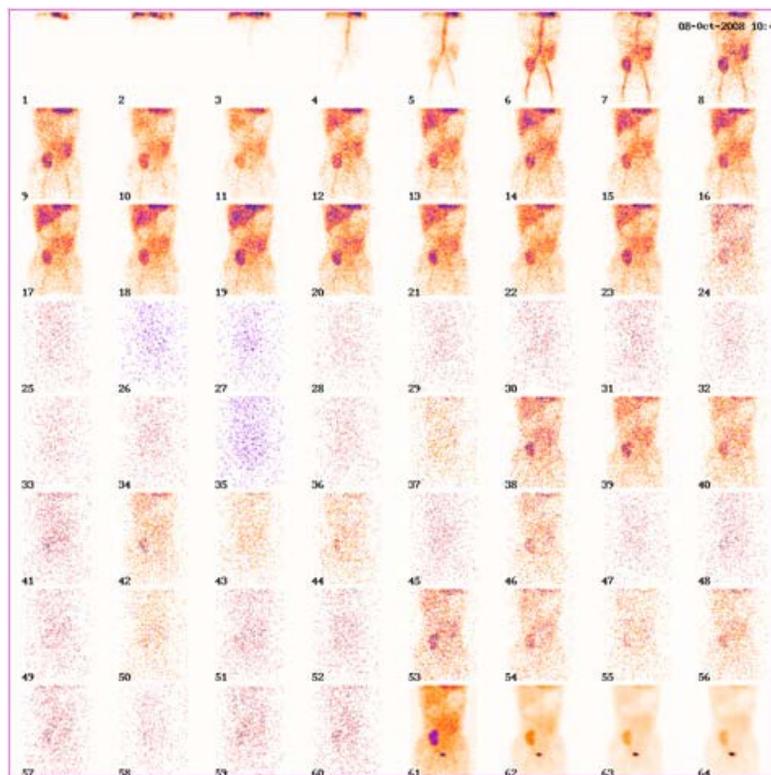
Figure 1. ^{99m}Tc -DTPA renal scan (perfusion phase). Note loss of the contrast in some of the frames

Beginnings from frame number 24, the count in following frames are severely decreased, resulting in complete loss of contrast in some of the frames. Quantitative analysis showed that the total counts are fluctuating in different frames. These fluctuations in count density suggested an unstable system. We checked the software and hardware of the system thoroughly and a malfunctioning hardware which was used for controlling power supply of the system was detected. This malfunctioning hardware was responsible for transient shift of photopeak to lower portion of the energy window and beyond it. As a result only scattered photons were recorded. The hardware was replaced and the system returned to normal function.
